### EFFLORESCENCE

#### What is efflorescence.

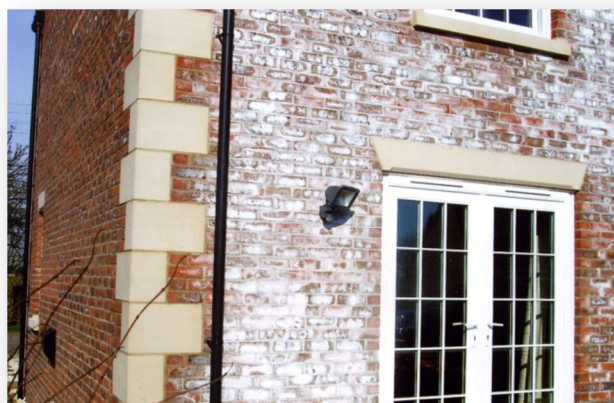
Visible as a harmless deposit of soluble material on the surface of brickwork, its texture may vary from light and fluffy to hard and glassy depending on its composition. The deposits consist of natural occurring soluble salts which vary considerably throughout the country, not only within the clays used for the manufacture of bricks but also in the constituents necessary for the production of the mortar i.e. sand and cement. Apart from the salts derived from the bricks and mortar, almost any salt can form efflorescence if it is introduced as a contamination from external sources. The quantities of salts involved are small and a tiny percentage of soluble sulfates in the bricks or the cement is sufficient to account for the amount of efflorescence usually seen.

**In considering remedial treatments, efflorescence is a transitory effect which should preferably be allowed to weather away naturally.**

- **dry-brushing with a soft to medium nylon/bristle brush (a wire brush should not be used). The residue should be collected and removed so that it does not re-enter the brickwork at a lower level.**
- **using a sponge dampened with clean water to draw out salts. Excessively wetting brickwork may force some re-dissolved salts back in to the brickwork which will re-appear as it dries.**
