## EFFLORESCENCE

## TECHNICAL INFORMATION SHEET 2

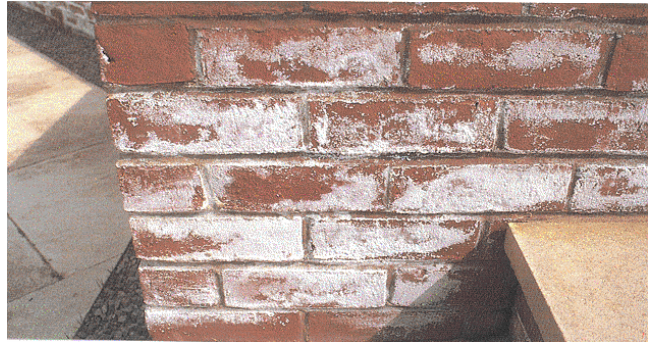
Visible as a harmless deposit of soluble material on the surface of brickwork, its texture may vary from light and fluffy to hard and glassy, depending on its composition. The deposits consist of natural occurring soluble salts which vary considerably throughout the country, not only within the clays used for the manufacture of bricks but also in the constituents necessary for the production of the mortar i.e. sand and cement.

Salts in brickwork are dissolved by the water which is introduced during construction or from rain. As the wall begins to dry out, the solution of salts becomes more concentrated and the dissolved salts will be deposited on the surface of the brickwork. This tends to be more prevalent at low temperatures, i.e. early Spring.

**In considering remedial treatments, efflorescence should preferably be allowed to weather away naturally. Its removal can be accelerated by dry-brushing with a soft to medium nylon/bristle brush.**

**A wire brush should not be used.**

**The residue being collected and removed so that it does not re-enter the brickwork at a lower level.**

**The use of a silicone treatment should be avoided since this can result in more permanent problems.**
