IRON STAINING OF CLAY BRICKS

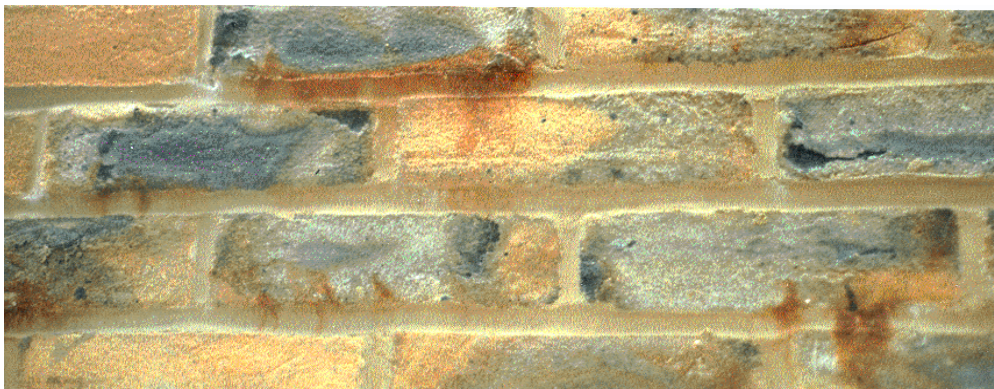
If the stain remains only on the bricks then arguably the discoloration may not cause too much concern. However, it does tend to run, and very quickly discolours the mortar joint as well.

Work carried out over a number of years showed conclusively that saturation of immature brickwork is the main cause of the problem.

On mortar joints the simplest method to quickly improve the appearance, is to clean the joints with a half round file. This readily removes the stain from the joint and restores the brickwork profile.

If total cleaning is required, the use of any propriety brand of brick cleaner, used as part of the normal cleaning down process, will remove the stain and any minor staining reoccurring should be allowed to weather away naturally.
