STAINING OF BLUE BRICKWORK (PEACOCKING)

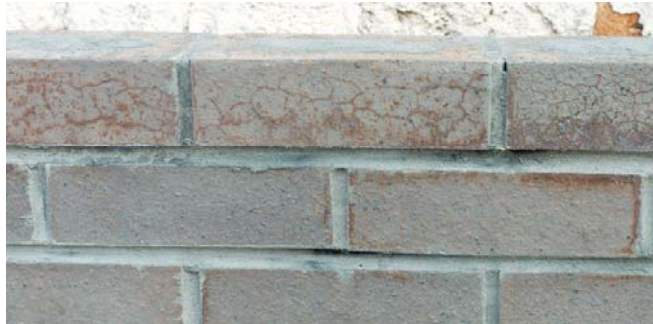
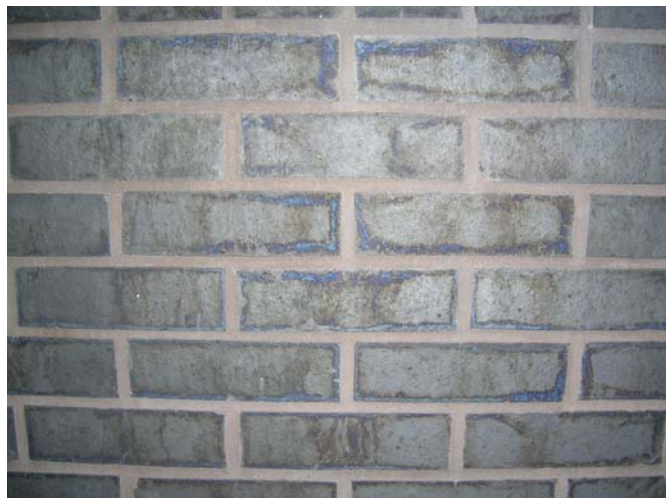
Blue bricks often exhibit an oily coloured type of stain, which may be referred to as 'Peacocking'. Stemming from the colours found in the feathers of the male Peacock and being similar to the swirling colours of oil on water.

The stain is very noticeable on blue bricks due to the iridescent effect of the brick's colour, which is caused by light diffraction through a very thin surface layer of colloidal silica.

The staining is usually the result of:

- a) By saturation of brickwork prior to the mortar curing. This gives a 'picture frame' effect, with the dark staining more apparent around the edges of the brick.
- b) Bricks coming into contact with copious amounts of water before being 'built in'. The manufacturing process uses a layer of silica sand to separate the bricks during the firing process. Without this the bricks would fuse together in the kiln. The residue of Silica on the bricks can turn blotchy when saturated.
- c) Direction water run-off from cementitious areas, i.e. floor slabs.
- d) A fine deposit of cement or lime transmitted to fine crazing lines by the moisture in the mortar at the time of laying.

All of the above are superficial and are not detrimental to the performance of the brick. Changing weather conditions can highlight some of the effects as can the initial drying out of brickwork.

To minimise the effects, good site practice should be adhered to following the recommendations in BS 5628: Part 3 'Code of Practice for Use of Masonry and BS 8000: Part 3, keeping stacks of bricks and newly laid brickwork as dry as possible and cleaning the brickwork down at the end of the job with a proprietary brick cleaner containing a brick detergent.
