VANADIUM STAINING/EFFLORESCENCE

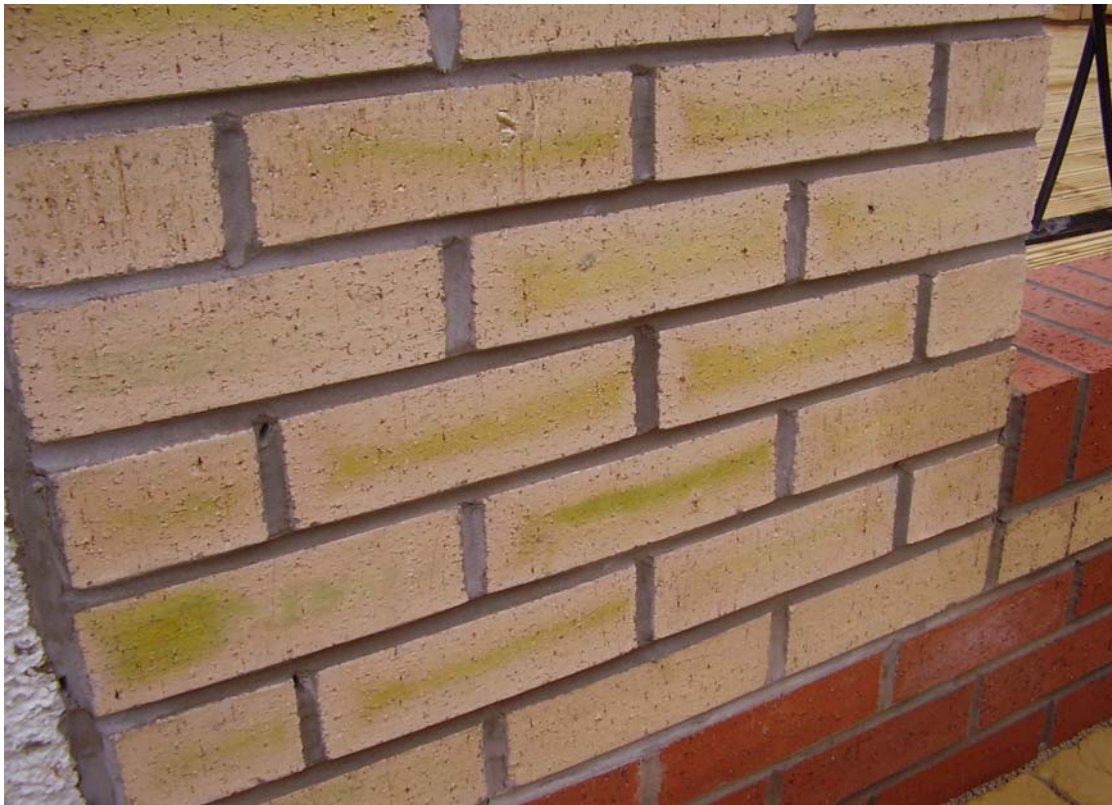
Like most soluble salts it requires saturation to bring it to the surface when it appears as a yellowish stain that may change to a greenish or even light brown colour.

Often occurring in conjunction with efflorescence it does not come and go in the same manner as a white efflorescence and should really be described as a stain.

The discoloration is only on the surface of the brick but its intensity and the speed at which it can appear during construction can be a cause of concern for the user.

Vanadium staining can be largely avoided by the protection of bricks and newly built brickwork to avoid saturation.

The stain will disappear in time due to the effect of normal weathering and should not return.

Under no circumstances should a standard acidic brick cleaner be used as this may "fix" the stain and turn it brown in colour.

If removal of the stain is required, brush on household bleach in concentrated form, when the stain is bleached apply a washing soda solution (12g/litre) and leave on the wall. Alternatively for more persistent stains, brush on an oxalic acid solution (100g/litre) and, when the stain is bleached apply a washing soda solution (12g/litre) and leave on the wall

It is important to stress that the hardening of the mortar joints and the protection offered within a completed building will eliminate any repetition of the problem.
