### DISCOLOURATION OF MASONRY DUE TO SATURATION

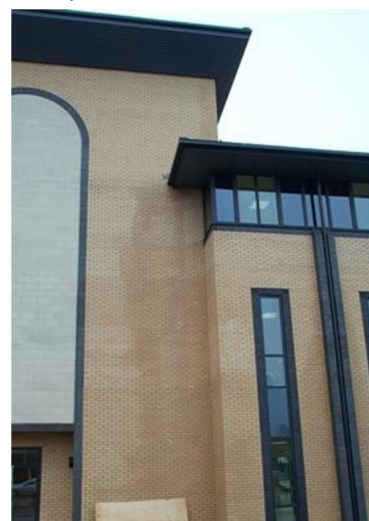
*Design detailing has caused saturation staining where water runs off roof ledges.*

Many materials used in construction are porous to a lesser or greater degree, whether it be stone, concrete, brick, mortar etc. This should be allowed for in design and detailing of buildings. Other materials such as glass, metals and plastics etc. are not absorbent and water will readily run off these components onto adjacent materials.

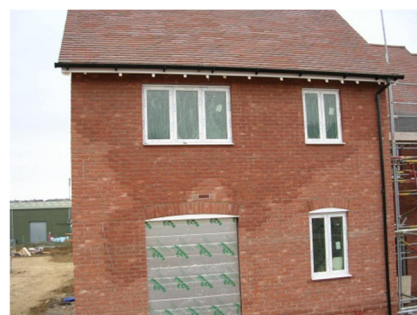
*Saturation occurring prior to roof & window placement.*

With brickwork, mortar takes at least a month to reach its optimum strength and hardness and the structure will need some care and consideration until then. Therefore it is likely that water can penetrate readily and saturate units whilst the building is in an unfinished state.

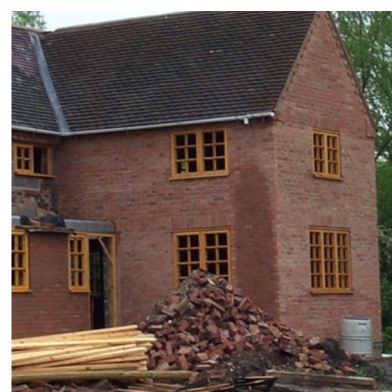
*Saturation occurring where downpipes have not been installed.*

During rainfall, saturation of masonry can be intensified by other components, for example rain-water outlets prior to the down-pipes being fitted or scaffolding boards adjacent to freshly constructed masonry. The after effects will be localised darkened patches.
