Site practice & troubleshooting
IRON STAINING ON BRICKWORK

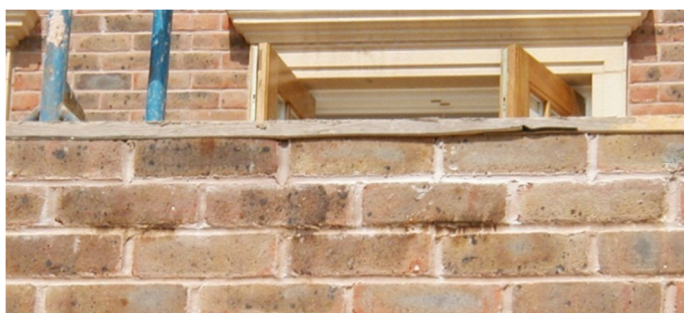
Iron salts can form a significant part of natural clay materials. Iron staining occurs on some "stock" bricks and on certain types of wire-cut bricks, particularly those made with clays with a high iron content. It takes the form of a dark brown stain leeching from the brick body.

If, after production, the bricks are exposed to saturation in certain conditions iron salts will migrate to the surface, in much the same way as the common white efflorescence, where they oxidise to produce a stain that is usually brown in colour, very similar to rust.

If the stain remains only on the bricks then arguably the discoloration may not cause too much concern. However, it does tend to run, and very quickly discolours the mortar joint as well.

When good site practice prevailed and bricks and brickwork were correctly protected by waterproof sheeting until the mortar was mature, the problem of staining is virtually eliminated.

The first 3 to 5 days after laying (dependent on season), brickwork is most vulnerable to the elements as mortar is still undergoing the hardening process. Newly erected masonry should be covered by waterproof sheeting to protect fresh mortar and open cavities to stop masonry becoming saturated. Once the structure is watertight, i.e. roof and windows in place, the building can commence the drying process.

On mortar joints the simplest method to quickly improve the appearance, is to clean the joints with a half round file. This readily removes the stain from the joint and restores the brickwork profile.

If total cleaning is required, the use of any proprietary brand of brick cleaner, used as part of the normal cleaning down process, will remove the stain and any minor staining reoccurring should be allowed to weather away naturally.
