Lime Staining of Brickwork

Issue 4, Jan 2010

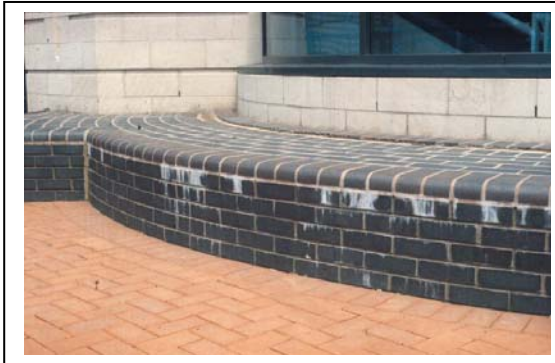
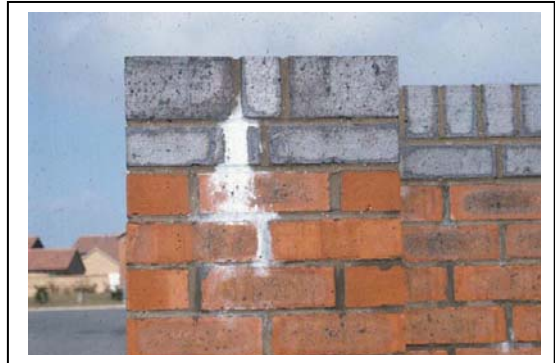
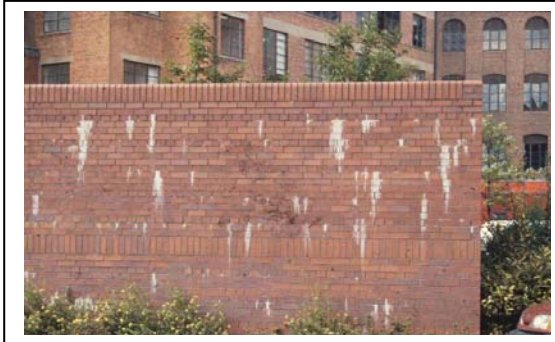
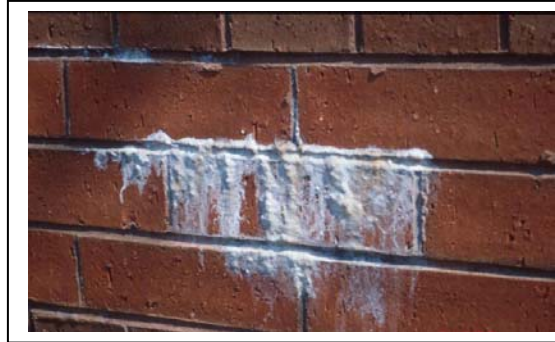
Lime staining is often mistaken as efflorescence, however, it usually emanates from mortar joints and doesn't disappear when wet.

Like efflorescence it needs saturation to transport the material, in this case free lime present in mortar or concrete and, as the water leeches out, it leaves the trailing effect shown above.

It is often clear where work has been left for the day without covering and a line of lime bleed-out staining appears where a downfall of rain has triggered the process.

Prevention is better than cure and the following points should be considered before and during construction.

- Care when detailing structures with close contact to concrete or cast stone which may allow lime to migrate into the brickwork.
- Correct installation of dpc's/ dpm's.
- Protection from rainfall during construction.
- Fully fill mortar joints so no pockets are left in which water can collect.
- Avoid direct run-off from floor slabs.

To remove fresh stains, scrub using a bristle brush and water, taking care not to damage the face of the bricks. For stains that have been exposed for longer and have started to carbonate, forming limestone, acid treatment is required.

Pre-dampen, not saturate, the wall to minimise its suction. Carefully apply a proprietary brick cleaning solution with a paint brush to dissolve the lime, then lightly scrub with a bristle brush and water.

If it hasn't disappeared after 3 attempts there is unlikely to be a significant improvement with further applications and specialist advice should be sought.

Testing on an inconspicuous area is advised and all health and safety guidelines from the cleaning solution manufacturer should be strictly followed.

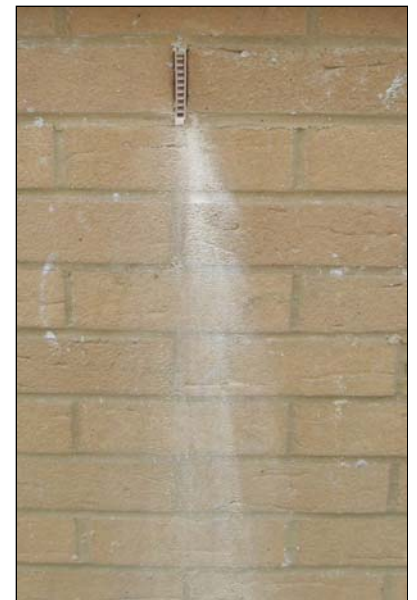
Sometimes around weep-holes in new buildings a trail of lime can be seen forming where water has emerged after picking up material from cementitious matter left in the cavity or from floor slabs etc. (see picture to right.)
