Discolouration of Masonry due to Saturation

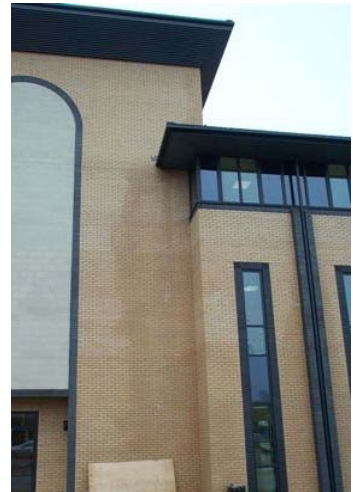
Darkened areas due to saturation

The after effects will be localised darkened patches.

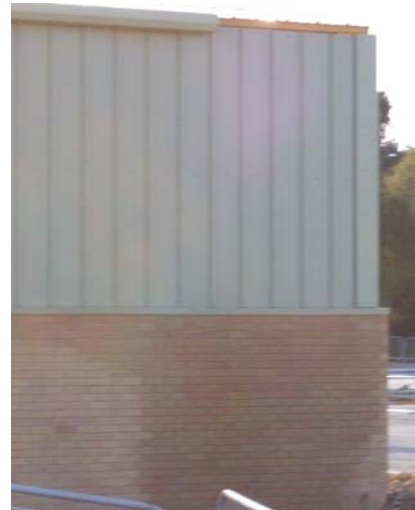
Saturation caused by missing guttering

During rainfall, saturation of masonry can be intensified by other components, for example rain-water outlets prior to the down-pipes being fitted or scaffolding boards adjacent to freshly constructed masonry.
